## BONDED REPAIR OF CORROSION

S.Verhoeven, C.B. Guijt, LtCol S.A. Fawaz

Center for Aircraft Structural Life Extension (CAsTLE)  
United States Air Force Academy

Aging Aircraft 2005  
(Topic area : Bonded Repair)

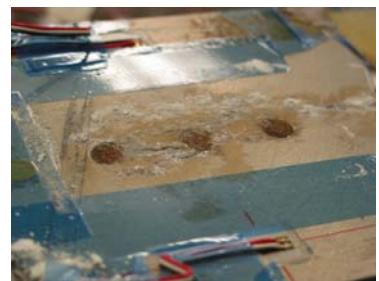
Upper wing skins on this transport, made out of 7000 series aluminum, have shown extensive exfoliation damage, mainly around the fastener holes, see Figure 1. Exfoliation corrosion is a form of intergranular corrosion associated with high strength aluminum alloys. Heavily worked alloys with a microstructure of elongated grains are especially susceptible to exfoliation. Corrosion products will build up along the grain boundaries and eventually result in layers of the material peeling or flaking off. Exfoliation often initiates at end grains encountered in locations such as machined holes, and can progress further into the material.

Figure 1: Example of exfoliation corrosion on upper wing skin

The current approach to deal with this damage is to remove the exfoliated material by grinding it out, and not replacing the removed material. Depending on the location on the wing, local grind-outs are allowed up to 25% of the skin thickness. However, if the exfoliation extends beyond this limit, this approach is no longer allowed since too much material is lost. Replacement of the wing plank might be necessary, making this damage very costly.

The purpose of the current research is to develop a bonded repair method that restores structural integrity to corrosion grind-outs deeper than 25% of the skin thickness, so that severe corrosion cases can be handled without the possible need for replacement. Specimens were tested in fatigue in order to come to the most efficient and durable repair concept.

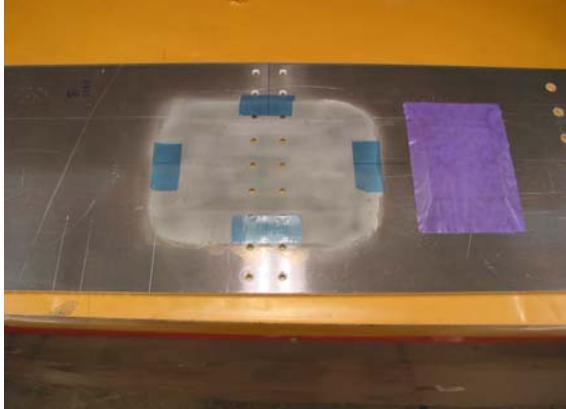
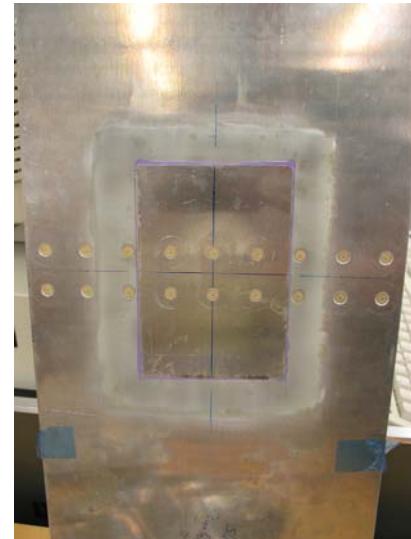
Figure 6 shows the specimen before and after bonding in the aluminum patch. As can be seen, the rivets have been re-countersunk through the repair.

Figure 6: Aluminum repair before and after bonding

The aluminum repairs that were used were made of 2024-T3 bare aluminum, with a thickness of 3.175 mm (0.125”). The aluminum repair is used in combination with the pyramid shaped grind-out (taper in two directions). Both the patch and grind-out were made using CNC milling equipment and therefore the patch was the exact positive of the grind-out.

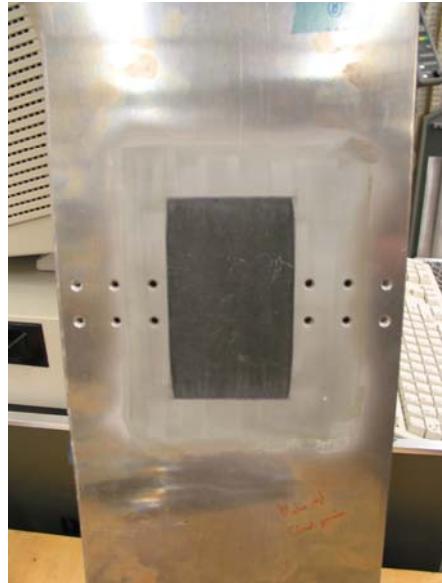
Figure 7: Boron-epoxy repair after bonding

- 13 plies of 5521/F4 boron-epoxy patch (Specialty Materials), ply thickness 0.136 mm (0.005")
- The stiffness ratio of the patch-substrate combination was 1.34.
- This repair was used in combination with the grind-out with only taper in loading direction. The patch follows the taper of the grind-out.
- The lay-up was uni-directional, inverted wedding cake, where the shortest ply is 76.2 mm (3") long and the longest ply is 136 mm (5.35")
- The hi-loks were countersunk at the bottom of the grind-out, after which the boron was bonded over the fasteners.

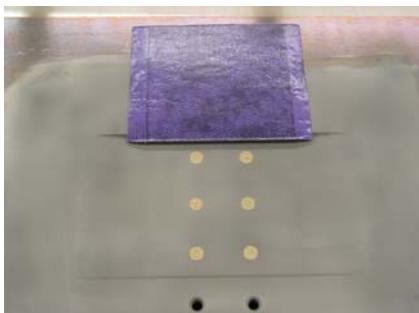
Figure 9: Boron-epoxy plies of the patch with 1 layer of EA9696 adhesive. Note the hi-loks at the bottom of the grind-out

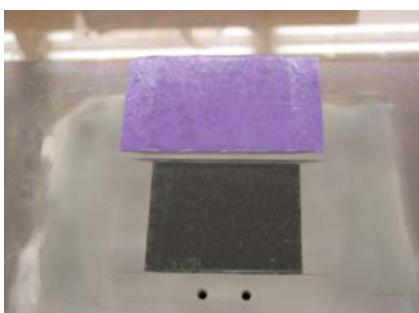
Figure 10: Boron-epoxy plies at bottom of grind-out, aluminum ply with EA9696 adhesive ready to be fitted. Note that the aluminum layer is longer than the boron-epoxy.

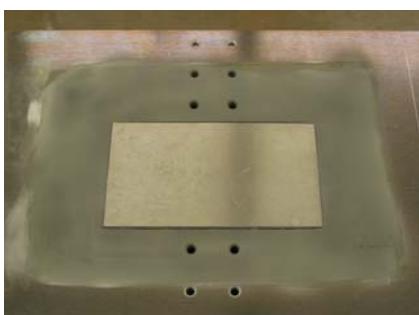
Figure 11: Hybrid patch installed

- 7 plies of 5521/F4 boron-epoxy, shortest ply is 76.2 mm (3"), longest ply is 94 mm (3.7"), taper ratio of 1:10, ply thickness 0.136 mm (0.005")
- 1 top layer of 2024-T3 bare aluminum with a thickness of 2 mm (0.08")
- Hi-Loks countersunk at the bottom of grind-out
- Stiffness ratio of the repair-substrate combination is 1.31

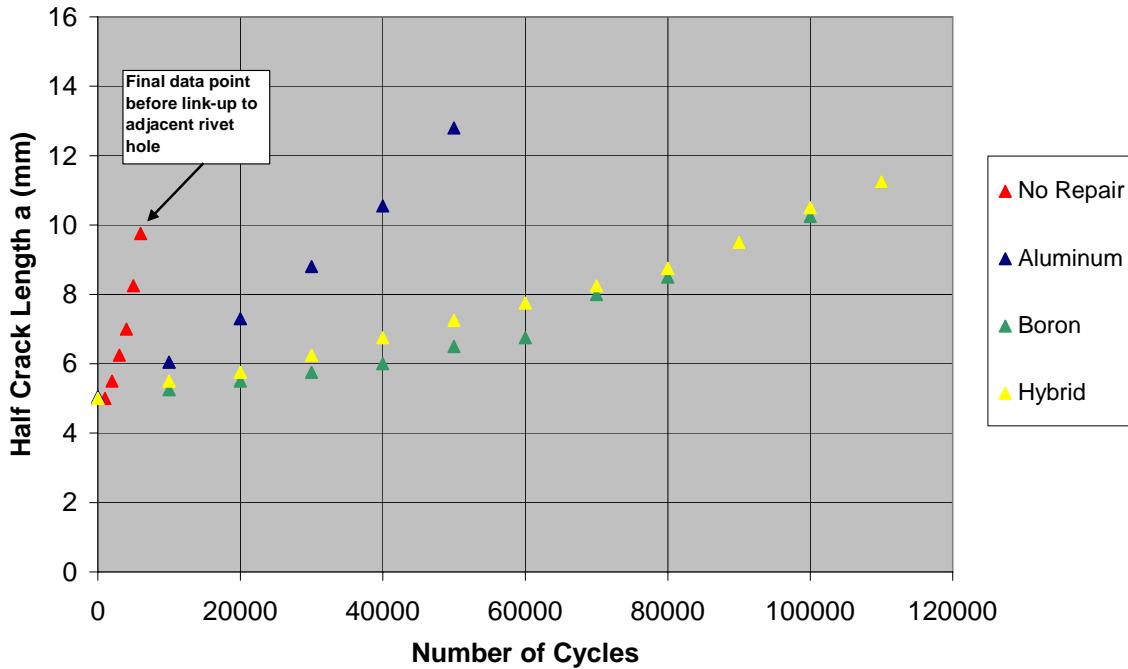
As can be seen from the graph, the unrepaired specimen showed rapid crack growth compared to the repaired specimens. The final crack measurement was taken before the crack linked up with the adjacent rivet-holes, which are 25.4 mm (1") away from the originating rivet hole.

As was to be expected, the hybrid and boron-epoxy repairs showed the slowest crack growth. This is due to the fact that the stiffness ratios of these repairs was higher than the stiffness ratio of the aluminum repair, which is limited by the requirement that the repairs must be flush with or within the contour of the skin. Using the boron-epoxy fibers that have an almost three times higher Young's modulus than the aluminum repair, allows higher stiffness ratios.

Figure 14 also shows that the boron-epoxy and the hybrid repair show a similar crack growth curve, despite the fact that the thermal residual tensile stresses under the boron-epoxy repairs are higher than for the hybrid repairs. This can be explained by the fact that the hybrid patch is thicker than the boron patch. The advantage of a smaller CTE mismatch for the hybrid patch is compensated by shear lag in the thicker hybrid patch, which is most noticeable in the absence of bending [4].

Figure 14: Crack Growth Curves for Constant Amplitude Specimens

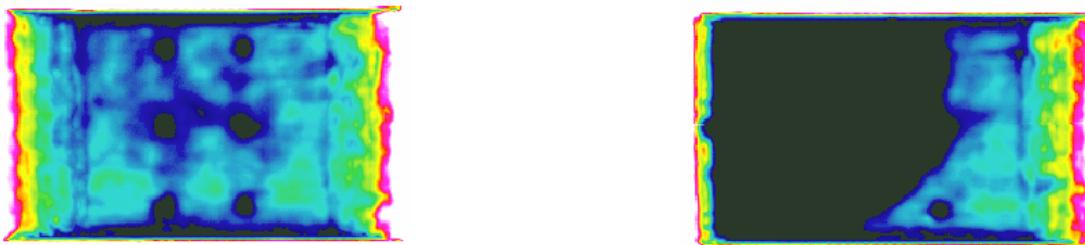
C-scanning the hybrid repairs after 1.5 million compression cycles showed no signs of disbonding or delaminations. When c-scanning the boron-epoxy repairs during the test, one of the repairs showed delaminations after as early as 250,000 cycles. Figure 15 shows an example of a c-scan for a boron-epoxy repair before and after testing. As can be clearly seen, more than half the patch has delaminated. It was determined that this was an interlaminar failure, not a failure of the bond line. It may be clear that this is a very unwanted failure mode, which would not have been noted in a static test.

Figure 15: C-Scan of Boron-Epoxy Repair Before and After Compression Test

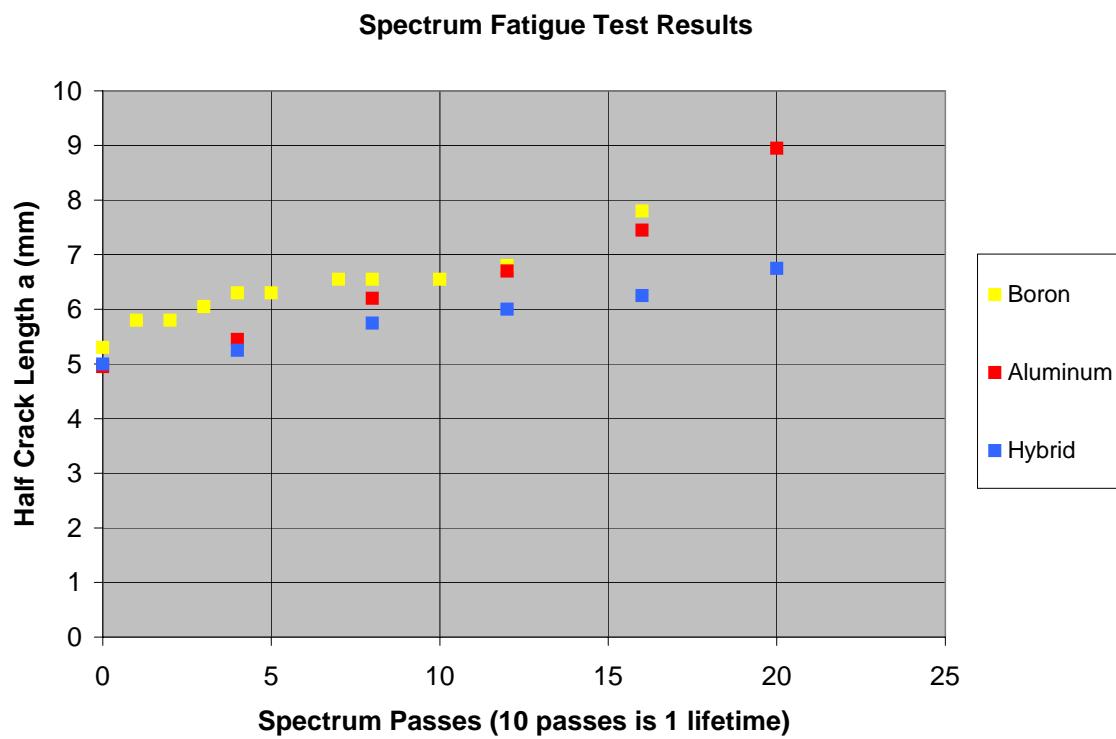
As can be seen, the hybrid repair is clearly performing the best, showing the smallest crack growth over 2 life times. None of the three hybrid repairs showed any signs of disbonding or delaminations after completion of the test. Also, no signs of patch cracking in the aluminum layer, no patch tip failure in the skin or crack nucleation anywhere else in the test specimen were observed.

Specimens with boron repairs showed crack growth that was irregular. Delaminations were found between 1.2 and 1.6 life times. They were initially found using coin tapping, and then confirmed using c-scan. Crack growth did not go up dramatically, supporting the conclusion that only part of the patch had delaminated and some layers were still bonded to the specimen and therefore still transferring part of the load over the crack.

The difference between the aluminum repair and the hybrid repair is slightly smaller to what was seen in the results from the constant amplitude fatigue tests. It appears that the aluminum is benefiting from the lack of thermal residual stresses, the cracks under the aluminum repairs do not grow while loaded in compression. However, crack growth is still very minimal considering that two life times were tested, and keep in mind that only twice the remaining life time of the aircraft has to be demonstrated. Also, the assumption is that no crack (other than an initial flaw of 0.005") why 0.005 instead of 0.05? radius corner crack) is present when the repair is bonded into the grind-out.

Figure 16: Crack Growth Curves for Spectrum Specimens
