# The Effect of *Ralstonia pickettii* on Environmental Fatigue Crack Growth of 7xxx Series Aluminum Alloys

<sup>1</sup> Center for Aircraft Structural Life Extension, 2354 Fairchild Drive, Suite 2J2, USAF Academy, CO 80840, United States

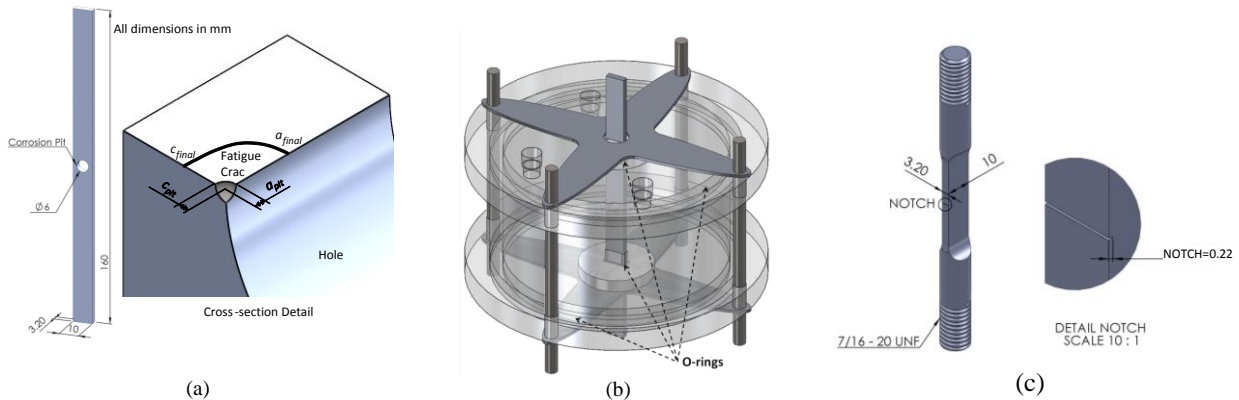
Figure 1: (a) Fatigue sample with a preferential pit for crack initiation used in stress life corrosion fatigue testing. (b) Environmental test chamber used for corrosion fatigue testing. (c) Single edge notch (SEN) specimens were made of 7xxx series aluminum alloy. All dimensions are in millimeters.

In 2011, stress life corrosion fatigue tests were being completed at varying stress levels and stress ratios ( $R$ ) of either 0.1 or 0.65 to examine the effect of a modern alloy and temper (AA7475-T7351) on the initiation of a crack from corrosion damage (pit) compared to a legacy alloy and temper (AA7075-T651) at a frequency ( $f$ ) of 1 Hz. Figure 1 shows the sample and test chamber used for this testing. Bacteria grew on some of the samples changing the fatigue life.

After the stress life testing was completed, the bacterial effect was examined using the direct current potential drop (dcPD) method to measure the effect on the crack growth rate. All fatigue crack growth rate testing was completed using a single edge notch specimen, shown in Figure 1. The fatigue test was completed at a constant  $\Delta K$  ( $6 \text{ MPa}\sqrt{\text{m}}$ ) over a range of frequencies (0.02-20 Hz) and at a stress ratio ( $R$ ) of either 0.10 or 0.65. The test parameters were selected to compare the crack growth rates to published inhibited corrosion fatigue crack growth rates using chromate and molybdate [5-7]. The corrosive environment was 0.06 M NaCl. The bacteria were allowed to grow naturally or intentionally added to solution to quantify the effect. To add bacteria to solution, colonies of *R. pickettii* were grown on R2A agar and single colonies were added to the 0.06 M NaCl solution. Figure 2 shows the growth of the bacteria on the aluminum sample. *R. pickettii* is known to build biofilms and the growth is thought to be a biofilm [4,8-10]. Figure 2b gives a schematic of biofilm development [8].

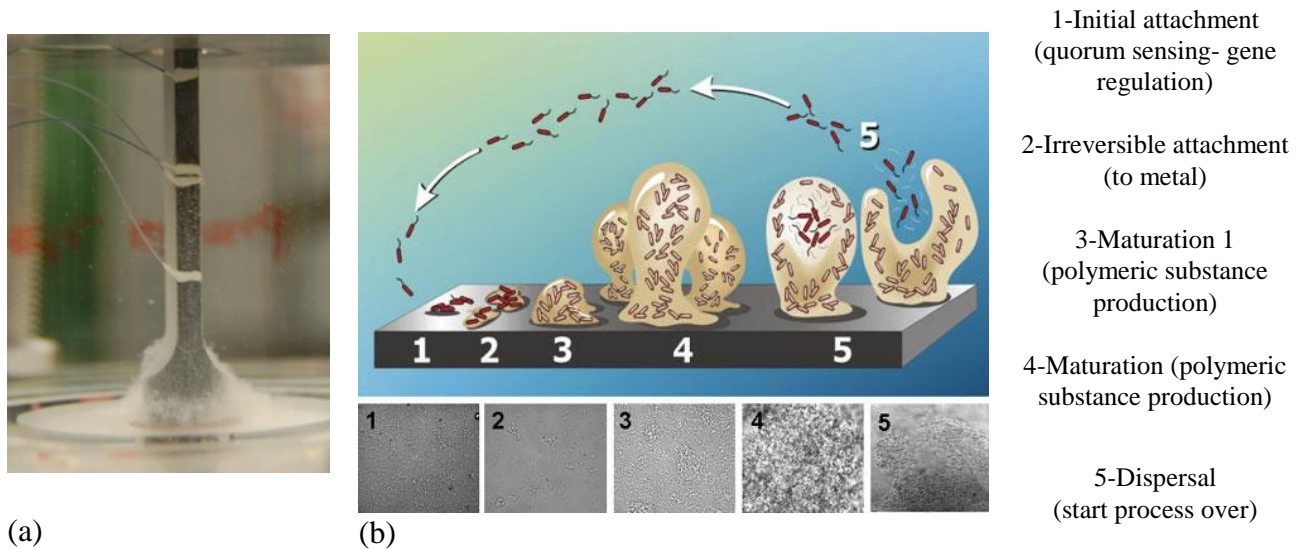
Figure 2: (a) Bacterial growth ("fuzz" at bottom of samples) on the 7xxx series aluminum alloy in 0.06M NaCl solution. The white on the dcPD wires is a protective coating. The fuzz continues up the entire length of the sample. (b) Biofilm development [8].

The results from the stress life fatigue testing showed that the presence of the bacteria during the tests completed with an  $R=0.1$  saw approximately 5-fold increase in fatigue life. The samples tested with an  $R=0.65$  saw a 6-fold increase in fatigue life. Figure 3 shows the comparison of high and low amounts of *R. pickettii* when added to a 0.6 M NaCl solution to a known corrosion fatigue inhibitor chromate ( $\text{Na}_2\text{CrO}_4$ ) at  $f = 1$  Hz [5]. The addition of 0.3 M of chromate lowers the fatigue crack growth rate for frequencies just below 1 Hz; when 0.5 M chromate is added, the inhibition occurs over the entire frequency range (0.1-70 Hz) [5]. The amount of bacteria was quantified visually, based on the amount of “fuzz” seen. For crack lengths of 2-4 mm both the high and low bacteria

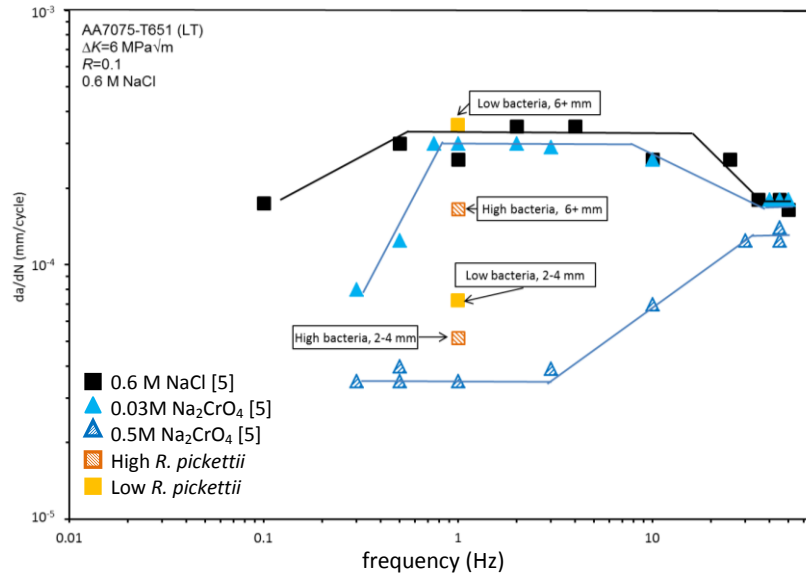
Figure 3: Comparison of the effect of *R. pickettii* on fatigue crack growth rates on AA7075-T651 to a known corrosion fatigue inhibitor chromate at  $\Delta K=6 \text{ MPa}\sqrt{\text{m}}$ ;  $R=0.1$ ,  $f=1 \text{ Hz}$  in  $0.6 \text{ M NaCl}$  [5].

concentrations slow the crack growth rates to that of high amounts of inhibiting pigments [5]. For the 6-6.5 mm data the inhibition appears to be less effective particularly for the low bacteria case. However it should be noted that the presence of the bacteria can cause the dcPD system to under-measure the crack length (increases conductivity of the sample) which means for a constant  $\Delta K$  test, where the load is being constantly adjusted, an overload is applied. Based on post-test analysis of the crack length, the 6-6.5 mm crack length data is likely between  $\Delta K=10-14 \text{ MPa}\sqrt{\text{m}}$ , meaning that inhibition is still occurring even though the figure suggests it is not.

*R. pickettii* consistently shows inhibition on the order of known corrosion inhibitors as shown in Figures 3 and 4 [5-7]. The reason for this inhibition is currently unknown, however there are three leading theories being investigated: (1) *R. pickettii* is sequestering metal (copper) into its cell wall which is stabilizing the passive film at the crack tip [3,10,11], (2) the bacteria is producing oxygen which is causing an oxide layer to develop and protect the crack tip, (3) the polymeric biofilm the bacteria produces allows for protection of the crack through an inhibitive species or coating [14]. *R.*

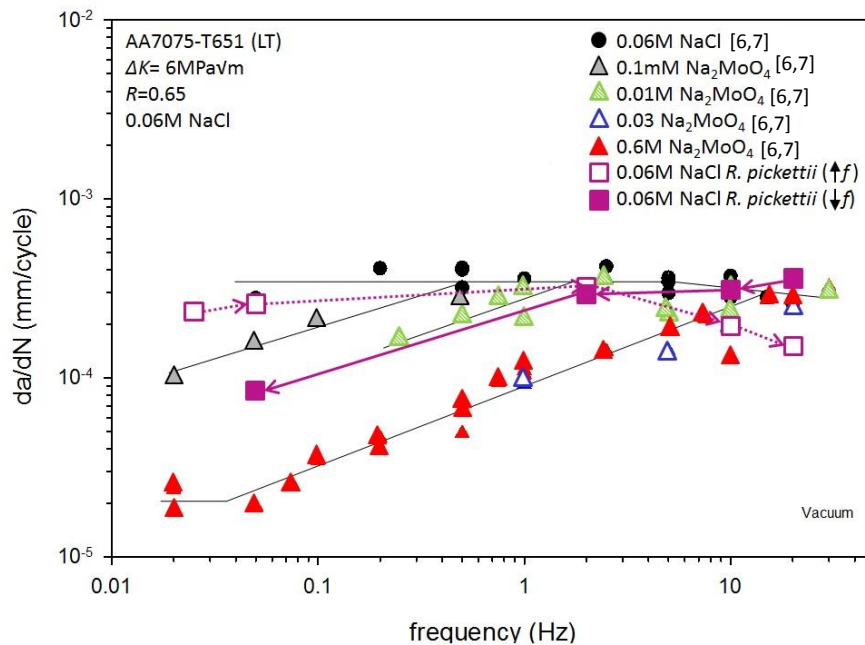
Figure 4: Comparison of *R. pickettii* inhibition to a known corrosion fatigue inhibitor, molybdate, at a constant  $\Delta K$  of  $6 \text{ MPa}\sqrt{\text{m}}$ ,  $R$  of 0.65 over frequencies from 0.02 to 20 Hz [6,7]. The arrows denote the order of testing.

A large database of inhibition of corrosion fatigue crack growth by a corrosion replacement inhibitor, molybdate, has been published [6,7]. That work found that with inhibitive salts thought to form a passive film at the crack tip testing at an  $R=0.65$  produced better inhibition so a comparison with *R. pickettii* was completed over a range of frequencies. Figure 4 shows the comparison between *R. pickettii* and molybdate [6,7]. Again in this figure the progression of inhibition by increasing (0.1 mM to 0.6 M) levels of molybdate can be noted, with the 0.6 M molybdate slowing the crack growth rate to that of vacuum at 0.02 Hz. The tests were run as frequency scans, starting at either the high (20 Hz) or low (0.02 Hz) frequency and then progressing in the order of the arrows. Each frequency scan would take on the order of two weeks to complete. The results showed that if a test is started before the bacteria has had time to become visible ("fuzzy") from Figure 2 then inhibition of the crack growth rate does not occur, however once the fuzz is visible then inhibition can occur even up to frequencies of 20 Hz. It should also be noted that the reduced flushing of the crack tip caused by the increased stress ratio does not increase the ability of the bacteria to inhibit corrosion fatigue when compared to the testing completed in comparison with chromate shown in Figure 3 [11].

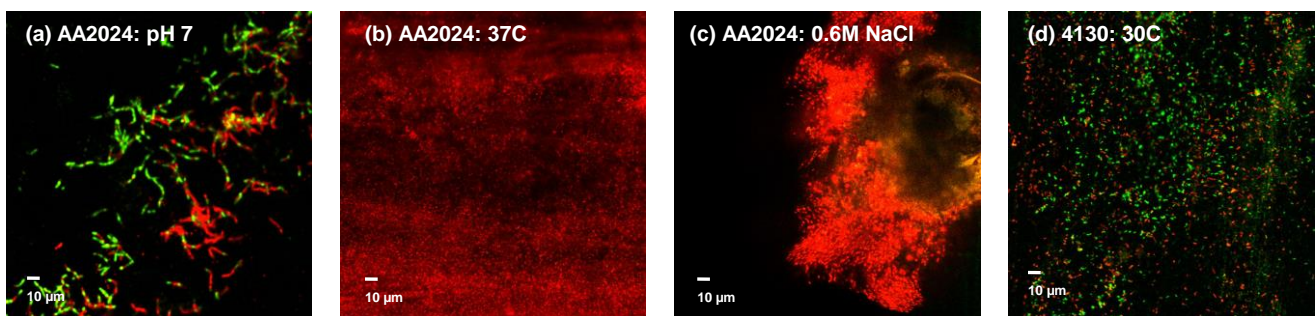
Figure 5: Development of a *R. pickettii* biofilm under varying conditions; pictures and charts [16].

Work is underway to analyze the structure of the biofilm. The early research has looked at how the biofilm develops under varying conditions in an effort to understand why the biofilm sometimes appears to be produced faster and thicker than at other times [16]. Figure 5 shows the development of the *R. pickettii* biofilm using a live/dead stain with confocal microscopy under varying temperatures, pH, and salinities and with various alloys. The amount of growth and living bacteria is rated from no growth/living (-) to heavy biofilm/all living (++++). It appears that a neutral to slightly basic pH (7-8) allows for string-like bacteria formations (5a). Higher temperatures (30 and 37 °C) (5b) and low salt content (0.06 to 0.6 M NaCl) (5c), or neutral to slightly basic pH (7-8) cause thick biofilm formation. Formation on 4130 steel is scattered but not stringy (5d). Interestingly these are conditions very close to what exist in the corrosion fatigue test cell.
