Stress Corrosion Cracking Rates for 7079-T6 Sheet

Molly R. Walters, Sandeep R. Shah and Scott A. Fawaz
Center for Aircraft Structural Life Extension (CAStLE)
Department of Engineering Mechanics
United States Air Force Academy
Colorado Springs, Colorado 80840

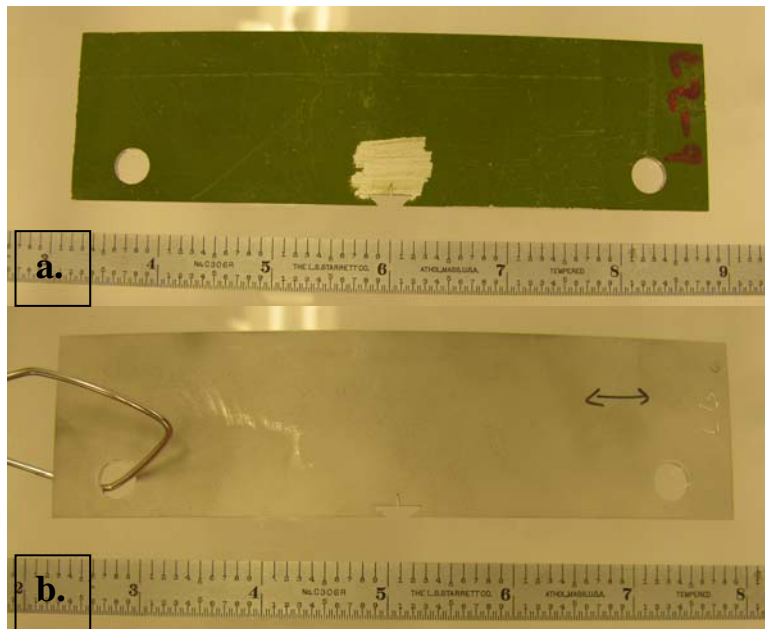
Figure 5. Coated and uncoated samples. Figure "a," above, has chromate coating covering the surface except for the machined edges of the part and the notched portion of the sample, where coating removal was necessary to machine the notch with EDM. Figure "b" was soaked in acetone to soften the coating, then scraped clean before final machining.

The specimens for this study were taken from a panel of the original fuselage crown skin which was replaced after noticing cracks. Care was taken to avoid any defects in the specimen while cutting them from the panel. For the first set of tests, the primer and paint were kept almost intact except at the notch. The paint was removed near the notch area to allow for an electrical path during electrical discharge machining (EDM) of notch. However, in the later tests, coatings and primers were completely removed. Surprisingly, the specimens with coatings and primers removed exhibited almost two decades slower crack growth rate as compared to their un-stripped counter parts. The in-service panels are coated with chromate

conversion coatings, widely used in 1960s and 1970s. The accelerated crack growth rate in specimens with coatings could be attributed to preferential corrosion in the uncoated area. Simply, on an uncoated sample, corrosion may attack at any surface since there is no chemical or physical barrier to prevent it, it may propagate evenly. On a coated sample, the edges and the machined notch are the only exposed areas of the sample where corrosion may occur until there is a crack, see Figure 5. Then the crack will be more likely to suffer preferential corrosion because fresh material is constantly being exposed as the crack propagates.

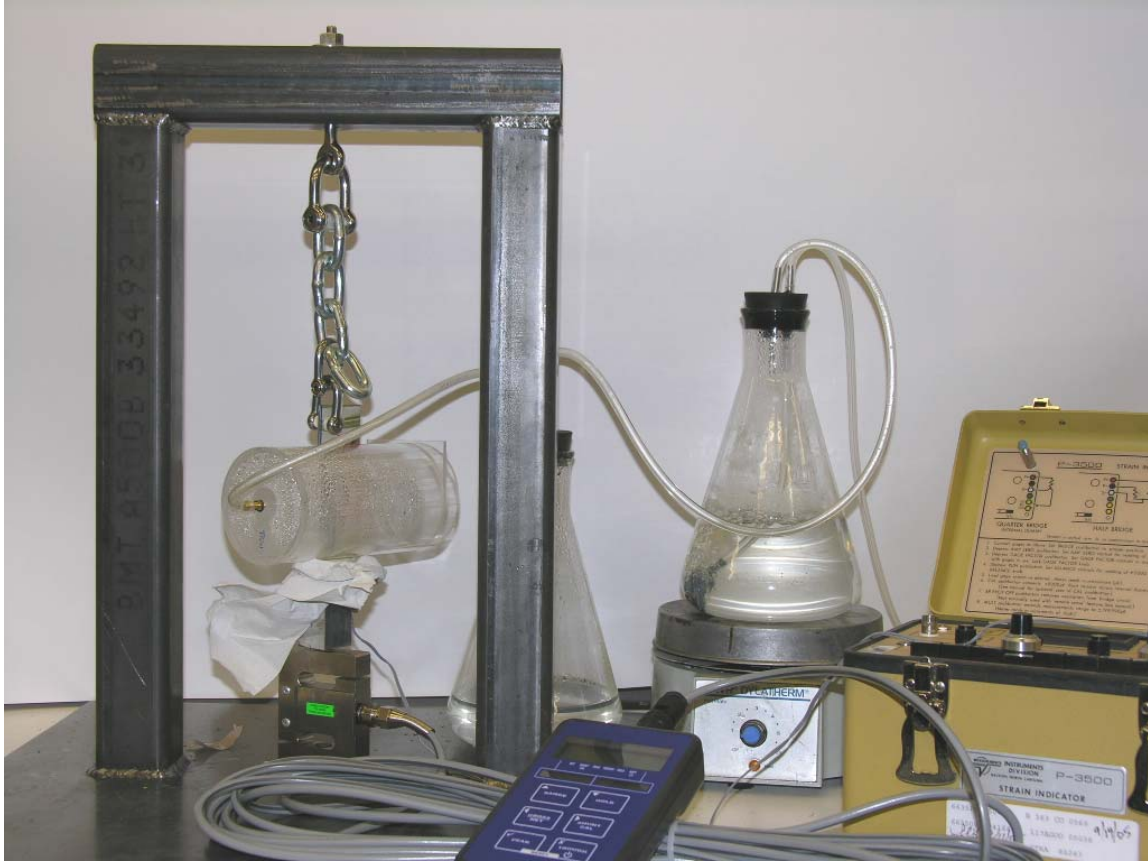
Figure 7. Constant displacement load frame with DI water fog environment.

Initially, constant displacement tests were considered the best option because they would provide slow cracking and near-constant K values. This would be beneficial because data was to be taken manually. For this type of test, a frame, see Figure 7, was built from 2" square steel tube and the final assembly consisted of a load cell, Lebow 1000 kg capacity, connected to a clevis. The specimen was linked to another clevis on top. Chain was connected from the specimen's top clevis to a yoke with a threaded rod attached to the frame. The rod went through the top of the steel tube and came through the top of the frame. There a washer and nut secured the threaded rod such that the specimen was maintained at a constant displacement.

There were three environmental conditions for this test. The first one was deionized water fog using a test chamber as shown in Figure 7. This was tested to provide the most conservative bound of crack growth rates. Second, a saturated salt solution using the solution bath as shown in Figure . This was created by stirring NaCl, non-iodized table salt, into deionized water until no more of the salt could be dissolved. Last, a 3.5 mol/L NaCl test; it was prepared by adding 204.55g of table salt to 1L of deionized water again using the solution bath as shown in Figure . The saturated environment was tested as it was expected to accelerate crack growth to a maximum value as per the plot in **Error! Reference source not found.**

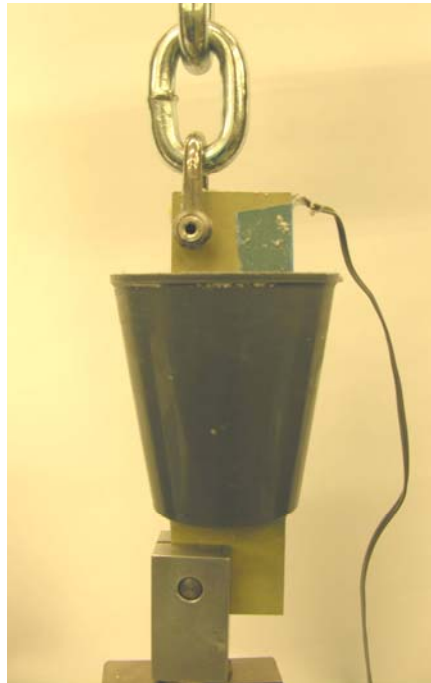
Figure 8. Specimen tested with cup in place for bath. Strain gage wire is also visible. No grips are immersed in the bath.

Another chamber was used to present a more severe condition at the crack tip. The environmental bath was created by cutting a small slot in the bottom of a plastic cup, then sealing the cup to the specimen with RTV silicone manufactured by Accumetric, Inc., see Figure . The solution could be poured into the cup and levels could be maintained to keep the crack submerged.

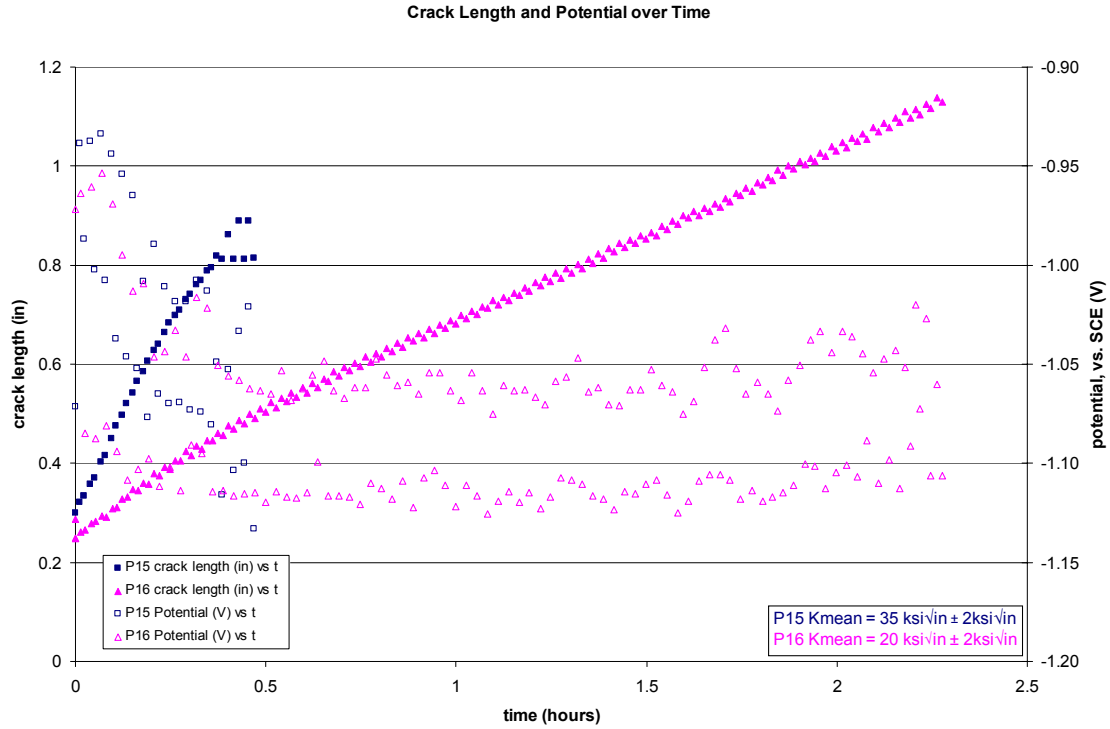
Figure 8. Crack growth rates and potential versus time for two coated samples with different stress intensity values.

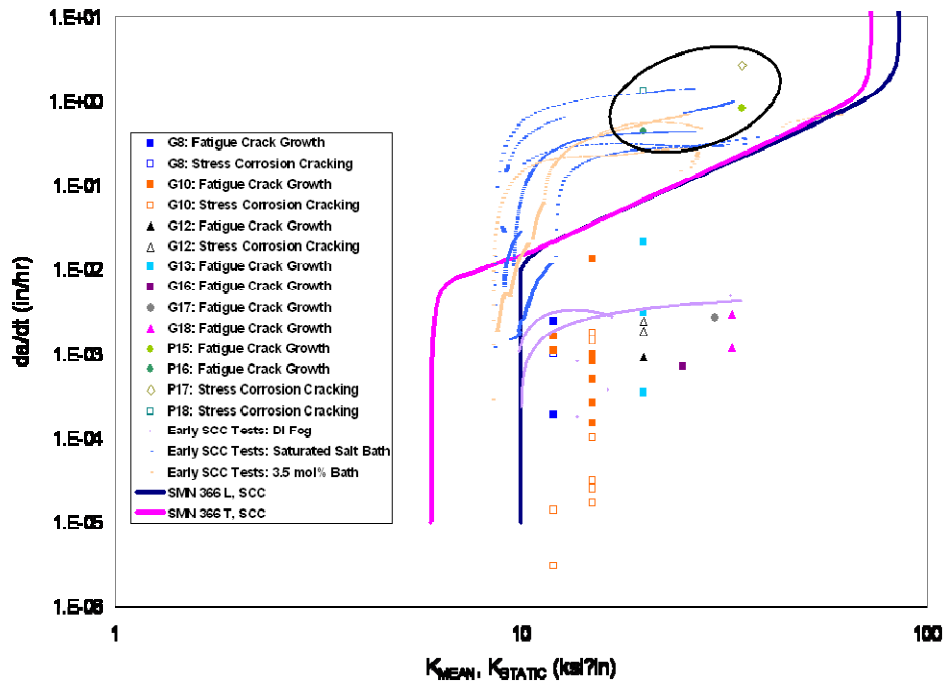
Figure 9. All tests were done in saturated salt solution. Crack growth rates were highest for coated samples. That data is circled. More detailed tabular data can be found in Appendix E.
