Stress Corrosion Cracking Rates for 7079-T6 Sheet

Molly R. Walters, Sandeep R. Shah and Scott A. Fawaz
Center for Aircraft Structural Life Extension (CAStLE)
Department of Engineering Mechanics
United States Air Force Academy
Colorado Springs, Colorado 80840

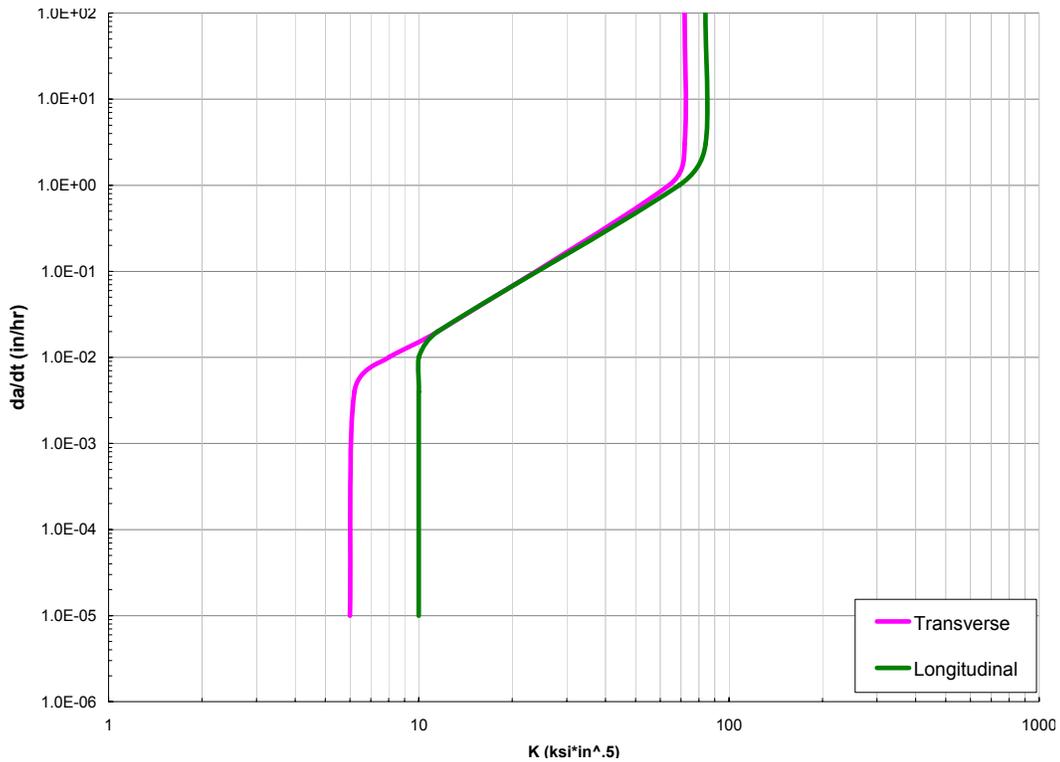
Figure 1. The OEM is currently using this unsourced data for their crack growth rate prediction models. The K_{ISCC} values for this data are 6 and 10 ksi√in for the transverse and longitudinal directions, respectively.

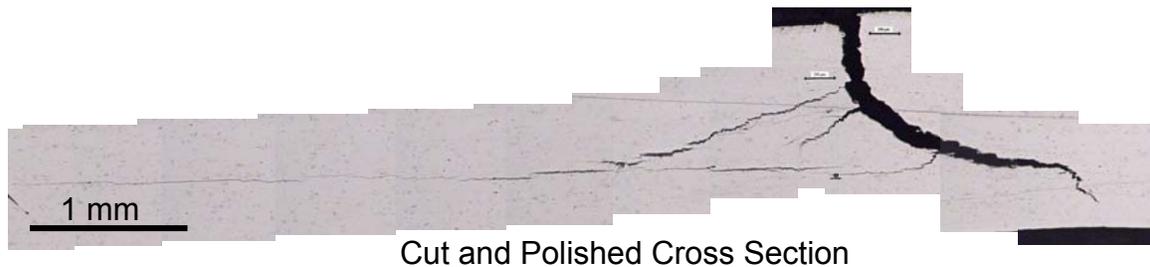
Cut and Polished Cross Section

Figure 2: Cross section micrograph of a typical crack on crown skin panel showing extensive branching and propagation of sub-surface in-plane cracks.

The crack shown in figure 2 initiated at the forward edge of the panel, just below the clad layer from extensive pitting. While propagating in aft direction from the initiation site, the crack branched and propagated in in-plane orientation just beneath the surface. This kind of crack growth is even more alarming as there are no suitable NDI techniques to confidently verify in-plane crack in a typical layered structure with sealants and paint between the layers. When these cracks were opened and analyzed in detail, significant corrosion deposits were noted on the surface of the crack. Washing of these products revealed the presence of striations on the crack surface as shown in figure 3.

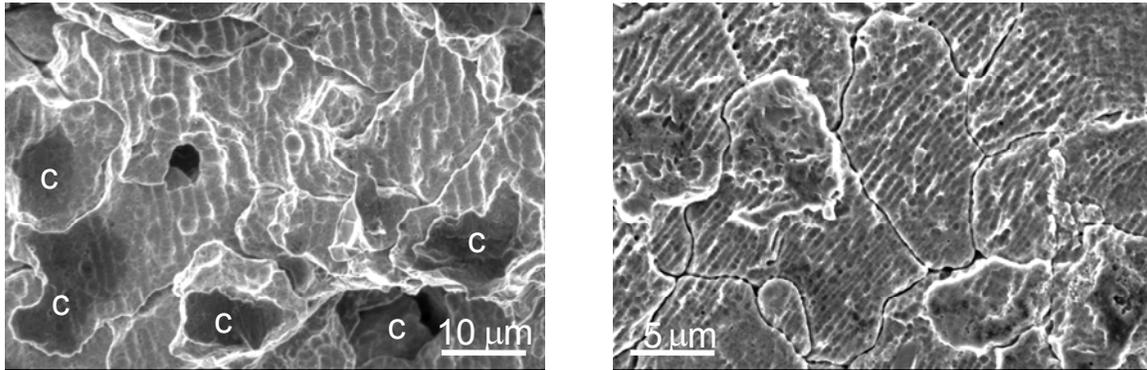
Figure 3: Crack surface after removal of corrosion products, showing striations on the surface.

This observation leads to intriguing questions about the crack growth mode in this panel. It is quite likely that SCC and fatigue both crack opening mechanisms are both operating. To separate out the effect of two mechanisms, it is necessary to know definitive crack growth rates in two mechanisms separately and combined together. In the present study we focus on getting reliable SCC growth rate data.

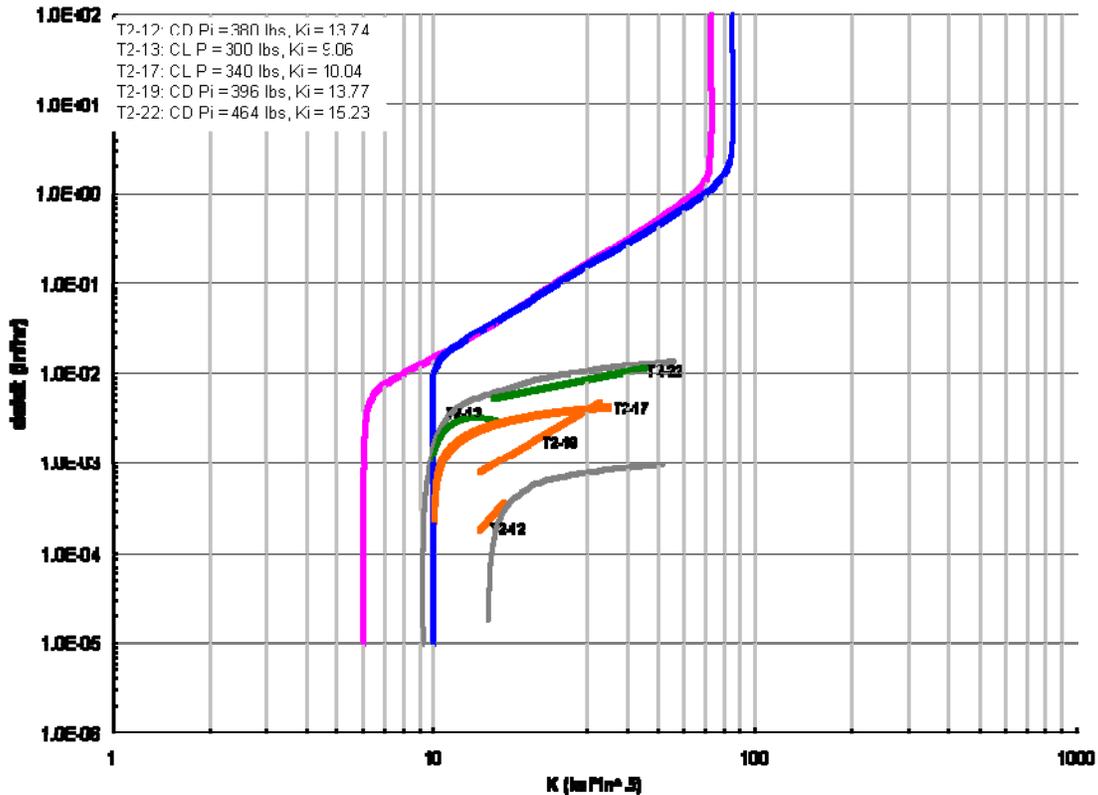
The crack growth rate versus stress intensity plots for the different environments are shown in figures 9, 10 and 11.. Also noted are the initial loads and initial stress intensity values for each test. In the results for the deionized water fog, Figure 9 shows rates about one decade lower than the OEM data and the K_I, initial stress intensity, values are higher than the transverse direction data—about 10 ksi√in rather than 6 ksi√in.

Figure 9. Crack growth rate versus stress intensity for deionized water fog. Scatter bands have been drawn in gray. In the legend, constant displacement is denoted by CD and constant load is CL. Rate data is much lower for this environmental condition, while K_I values are consistently lower than the published transverse data—about 10 ksi√in rather than 6 ksi√in.

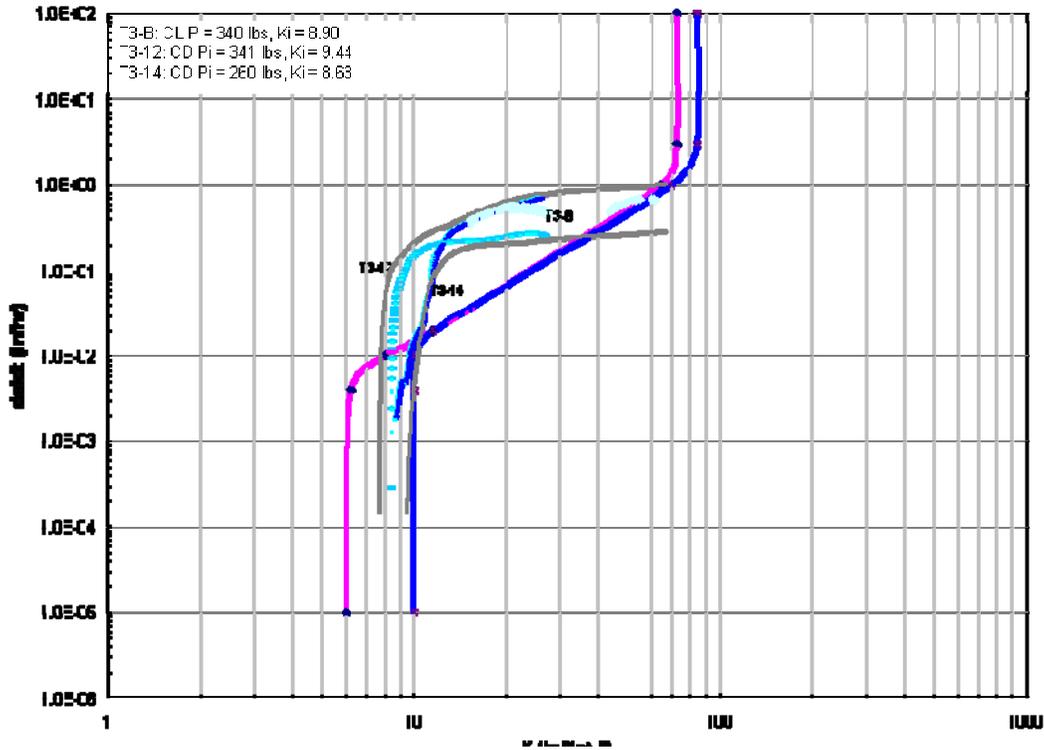
The crack growth rates for 3.5 mol/L NaCl bath were all higher than the OEM data. Initial stress intensity values were all lower than the test data in the DI fog condition, yet they were all higher than the referenced data. Three specimens were tested in this condition, see Figure 5.

Figure 5. Crack growth rate versus stress intensity in a 3.5 mol/L NaCl Bath. Scatter bands have been drawn in gray. In the legend, constant displacement is denoted by CD and constant load is CL.

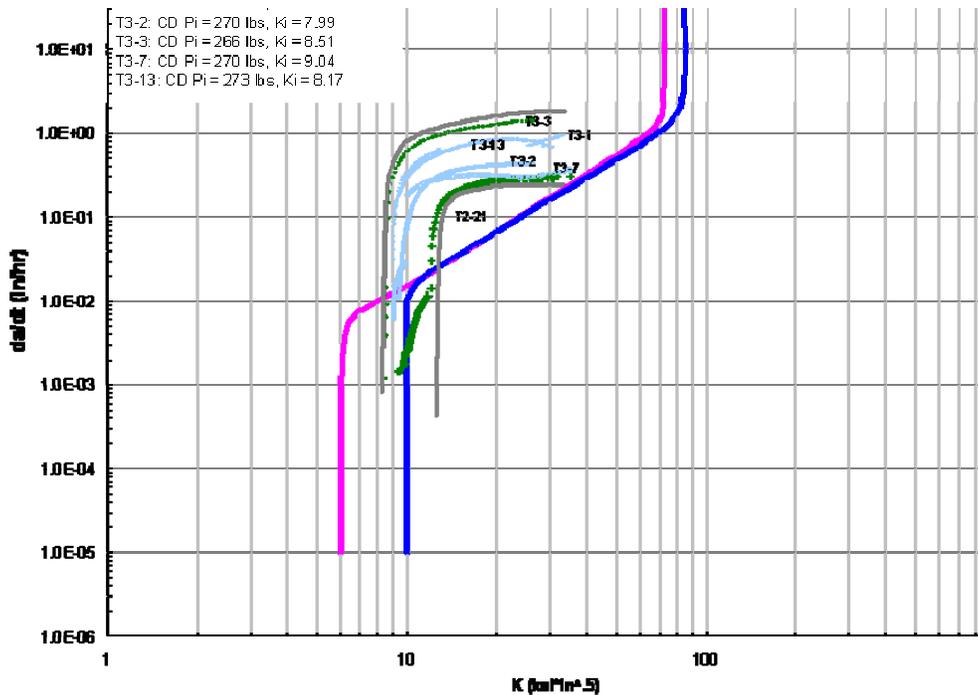
Figure 6. Crack growth rate versus stress intensity for saturated salt bath. Scatter bands have been drawn in gray. In the legend, constant displacement is denoted by CD and constant load is CL. Scatter is greater in this data set; about one decade wide, but this data set also presents the fastest growth rate found during this program—over one inch per hour.

The set of specimens tested in the saturated salt bath had one specimen with particularly high growth rate, over 1.00 inches per hour, see specimen T3-3 in Figure 6. Also, this set of specimens yielded the lowest calculated K_{ISCC} value; specimen T3-2 initiated a crack at 7.99 ksi√in. Saturated salt and 3.5 mol/L NaCl baths had very similar crack growth rates. The aggressive environments showed much higher crack growth rates than the DI water fog. For all three environment types, most specimens had relatively flat crack growth regions, whereas the OEM data did not show a region of constant crack growth rate.

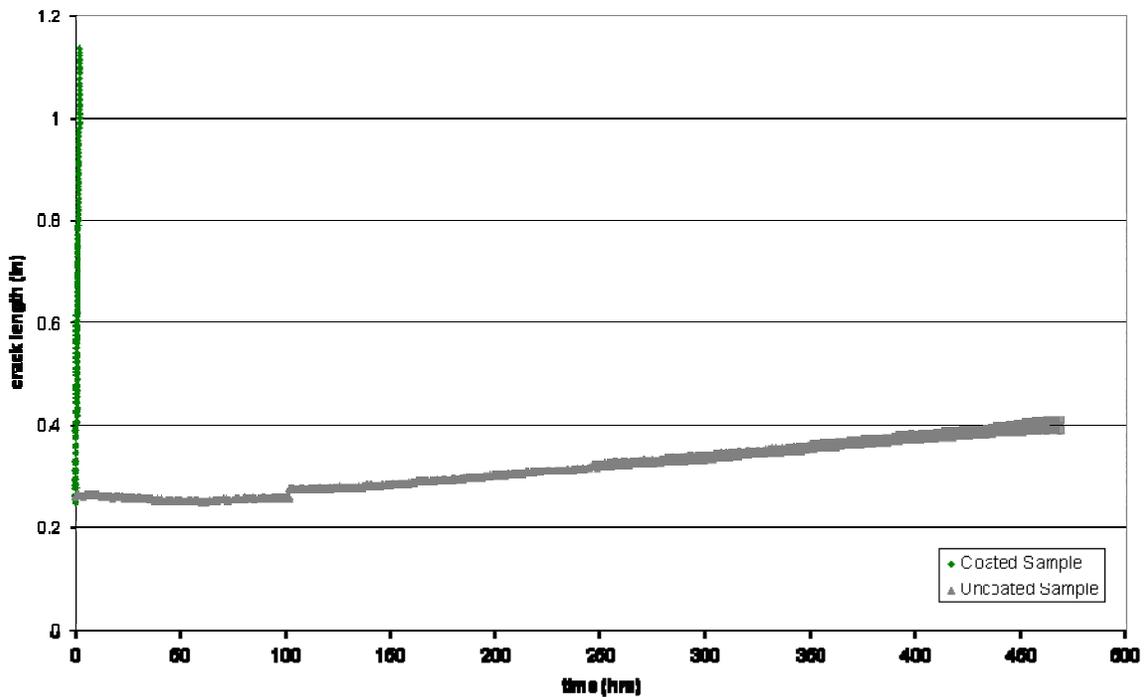
All these experiments were carried out on partially stripped specimens with coating intact on most part of specimen except near the notch. Constant K experiments were carried out on completely stripped specimens. Accelerated crack growth rate was observed for coated samples when compared to uncoated samples. See Figure 7. Corrosion potential was monitored for the later tests, submerged in saturated salt solution. See Figure 8. Figure 15 is a master plot of all the data showing constant load and constant displacement plots for coated specimens in comparison with constant K plots of coated and uncoated specimens. It also includes the data of constant K tests with superimposed small fatigue of ± 2 ksi√in over constant K_{mean}.

Figure 7. Crack velocity for coated and an uncoated specimen, both tested at 20 ksi√in. These samples were tested in a saturated salt bath.

Specimens containing intact coatings experienced higher crack growth rates than those with no coatings. The reason for this is not clear. The primer and paint stop any electrochemical reaction from occurring on the surface of the specimen. The reaction may be localized where the AA7079 directly interfaces with the salt solution. This may lead to preferential attack and accelerated crack growth.

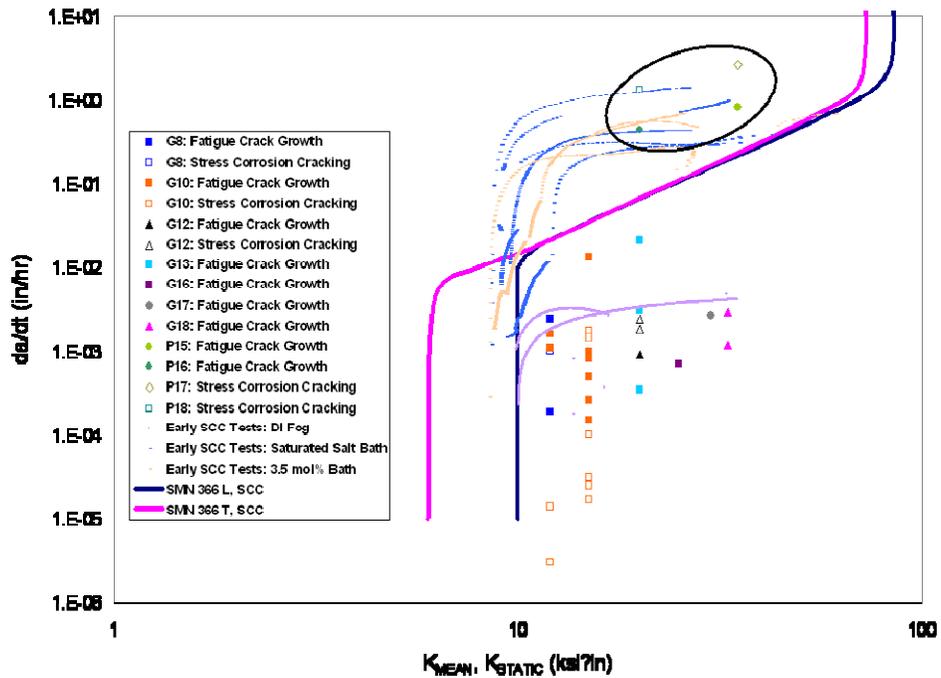
Figure 9. All tests were done in saturated salt solution. Crack growth rates were highest for coated samples. That data is circled. More detailed tabular data can be found in Appendix E.
